THE HUNTER'S HILL TRUST JOURNAL

Volume XXII No.3

OCTOBER 1993

HUNTER'S HILL COUNCIL'S NE

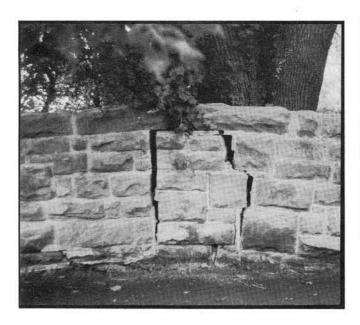
Mortared stone wall Stability of wall is damaged by roots of neearby tree: contact Council for advice.

faces and beds of each stone cut and roughly shaped with a pick - many faces sparrow pecked. An important consideration in repairing a mortared stone wall is to use a weak mortar, the guidelines recommend that in re-pointing the mortar, the correct constituents should be used otherwise a stronger Portland cement mixture may result in the sandstone crumbling. The recommended constituents are 1 part hydrated lime to 3 parts sand by volume. Very exposed areas can have 5% to 10 % Portland cement(by volume) added to the mix. The policy notes that lime mortar takes many days to harden, and months to reach full strength.
